Investigation of the Technical Service Life of Cured-In-Place Sewer Pipe Liners

Results from Literature Review, Interview
Campaign and Data Analysis

Report of the SEMA Berlin 3 Project

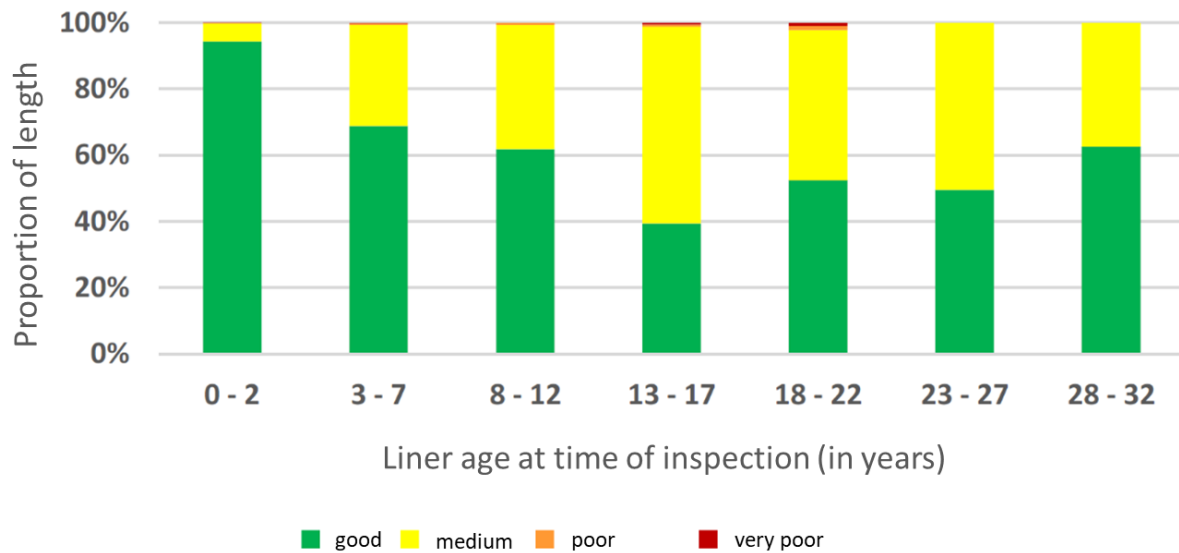
Based on the processed condition data, the SEMAplus condition distributions for different age groups, as shown in Figure 8, were determined. Across all analysed age groups, only 1.5 km of the examined liners are in poor or very poor SEMAplus condition (marked in orange or red). This corresponds to a very small proportion of just under 0.5% of the total examined liners. The most common types of damage found in these two rehabilitation-relevant SEMAplus condition categories include leaks, shards (holes in the liner with visible "liner fragments"), deformations, surface damage, material wear, and root intrusion. The latter remains classified in the poor SEMA category due to the incomplete review of all inspection videos. Overall, the proportion of liners requiring rehabilitation within each age group is low.

In Figure 8, a trend can be observed in the increasing proportion of liner lengths in the medium SEMAplus condition (marked in yellow) up to the age group of 13-17 years. According to data analysis, more than 95% of this deterioration is due to pre-existing damage that was rehabilitated using the liner, affecting approximately 165 km of liners classified in the medium condition category out of the total 332 km examined. This includes the previously mentioned manhole connection damages, which impact around 45 km of liners.

An interesting observation in Figure 8 is the trend of increasing shares of sections in good SEMAplus condition for age groups beyond 18 years. However, the representativeness of data in these older age categories is limited due to the significantly lower number of liners. Consequently, only the condition distributions of liners up to 17 years old will be used as the basis for deriving an updated liner survival curve. This trend provides a suitable foundation for adjusting the survival curves for liners used by Berliner Wasserbetriebe, as described in the introduction (Chapter 1), within the scope of available data. The assumptions derived from this data analysis for Berliner Wasserbetriebe and used for this adjustment are described in the following sections.

Figure 8: Condition distributions (ordinate) of the evaluated liners for the liner age groups at the time of inspection (abscissa); Figure from BWB
